Manhole Inspection Summary

Manhole # S39A2_006MH

Location Address: **3805 6th St.**

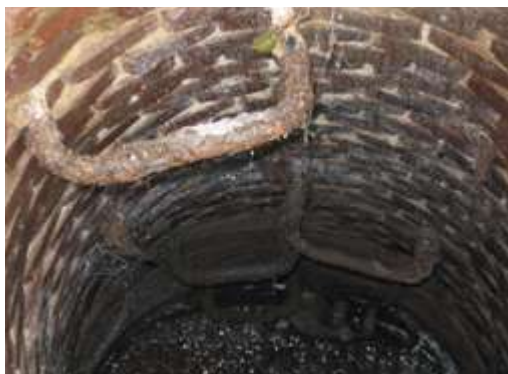
Steps Count: **5** Missing: **3** ☒ **Corroded**

steps

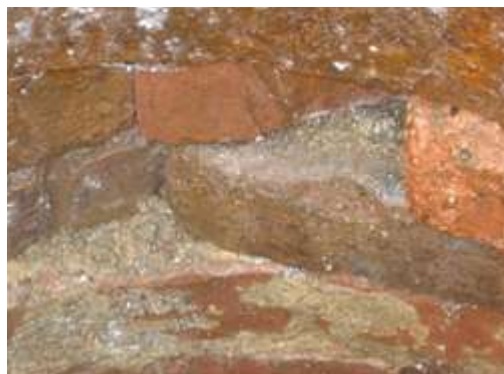
Defect 1

Condition: ☐ Sound ☐ Cracked ☐ Root Intrusion ☒ **Loose Brick** ☐ Deteriorated

Infiltration: ☐ None ☒ **Joint** ☐ Cracks ☐ Mortar ☐ Roots ☐ Wall

loose bricks

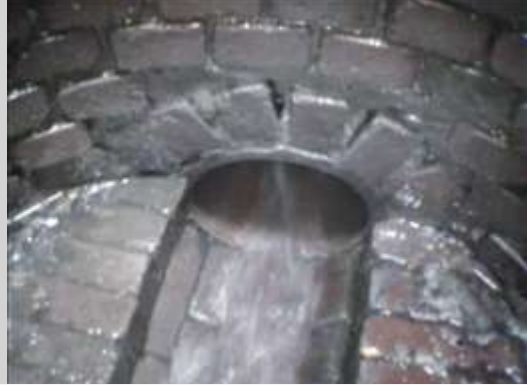
12 O'Clock Outflow

10 in. Circular Gravity Sewer
Pipe Out @ 12 O'Clock

Pipe Height: **9.6** (in.) Rod and Bar (Angled)
Pipe Material: **Clay** ☐ Pipe Lined
Invert Depth: **14.68** (ft.) Flow Characteristics: **Fast**
Deposits: ☒ None ☐ Mud ☐ Sludge ☐ Debris ☐ Grease
Silt Depth: (in.) Deposits Extent:
Infiltration: **None** Pipe Seal Cond: **Sound**

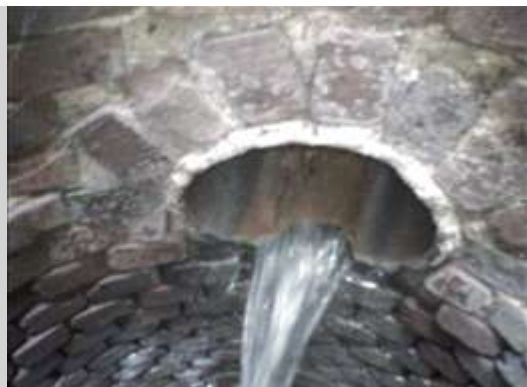
6 O'Clock Inflow

10 in. Circular Gravity Sewer
Pipe In @ 6 O'Clock

Pipe Height: **20.4** (in.) Rod and Bar (Angled)
Pipe Material: **Clay** ☐ Pipe Lined
Invert Depth: **11.96** (ft.) Flow Characteristics: **Fast**
Deposits: ☒ None ☐ Mud ☐ Sludge ☐ Debris ☐ Grease
Silt Depth: (in.) Deposits Extent:
Infiltration: **None** Pipe Seal Cond: **Sound**

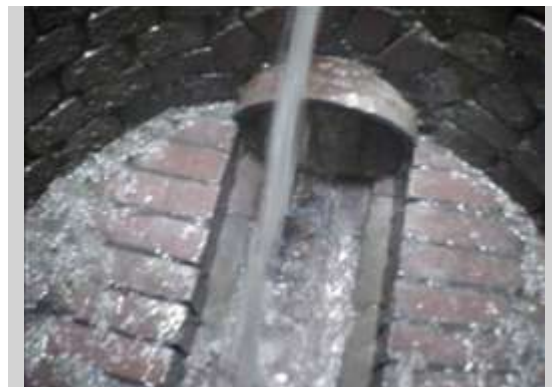
Drop In @ 6 O'Clock

Drop: **Inside** Rod and Bar
Angled: **Yes** Reading: **13.32** (ft.)
Inv Depth: **14.32** (ft.)
Drop Condition: **Open**
